Safety alert!

September 2011

Precast Panel Safety

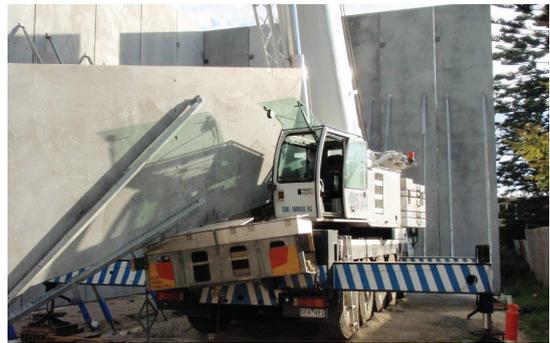
A rigger suffered a serious hand injury and a crane operator narrowly avoided death when a lifting insert fell out of this panel on a Charnley Vale site in Brunswick on 1 August.

Inserts in the 10 tonne panel that fell on the Charnley Vale site should have been the longer 'hairpin' type.

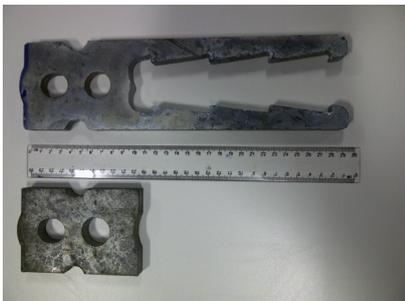
1. Use of incorrect lifting inserts

2. Lifting inserts not pinned correctly

Manufacturers have been advised that inserts should have two holes to allow them to be pinned with a hanger bar.

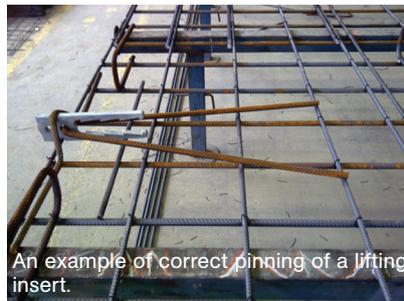
An example of correct pinning of a lifting insert.

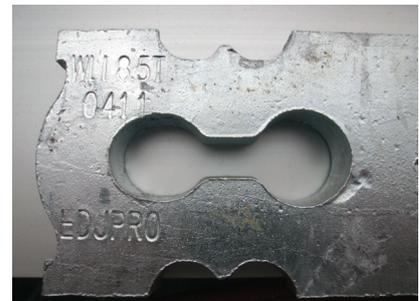
3. Inserts not marked with the correct information

The National Code and the Vic. Industry Standard require the following information to be exposed on the insert after the panel has been poured;

- The insert manufacturer's symbol or name
- The lifting capacity of the insert
- The insert length
