OH&S Alert!

March 2010

Tower Crane Operators - Check Your Cabin Windows

- Glass from broken window falls onto working deck
- Need to check if safety glass installed

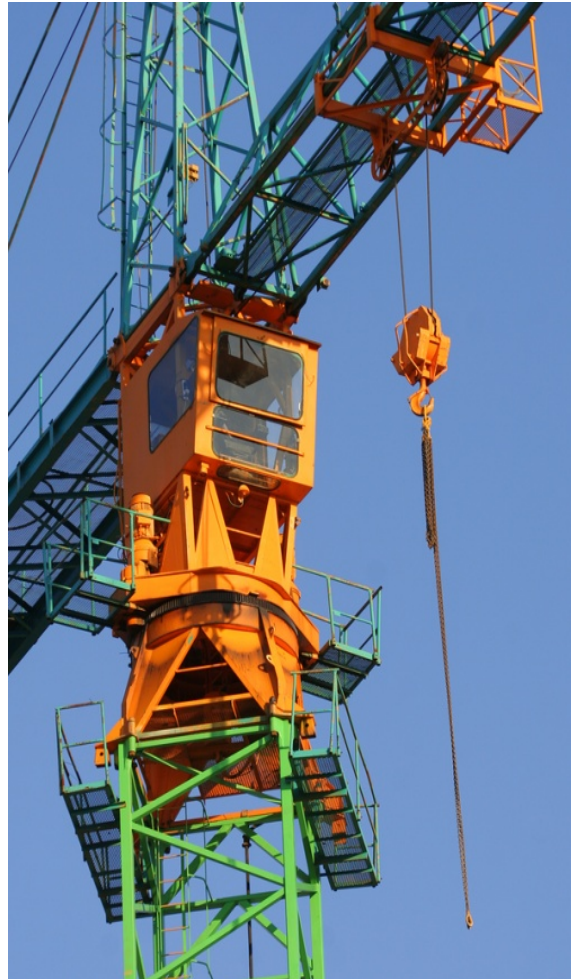
CFMEU safety officials were called to an incident in which the window of a tower crane cabin shattered, showering glass onto workers below. The window broke as the operator opened it normally.

The window that shattered was made of toughened glass. When it fractured, glass particles became loose and fell to the ground, just missing workers.

This hazard can be avoided by the use of laminated safety glass, which will keep glass fragments from coming loose and falling. A similar result can be achieved with window tinting film.

All operators should ask their employer or crane supplier if their cabin windows contain laminated safety glass. If not, measures should be taken so that if a window breaks, glass cannot fall onto work areas below.
